Lunker Federal #2-33-4H

Weekly Inspection Report

April 1 and April 4, 2013

Prepared for:

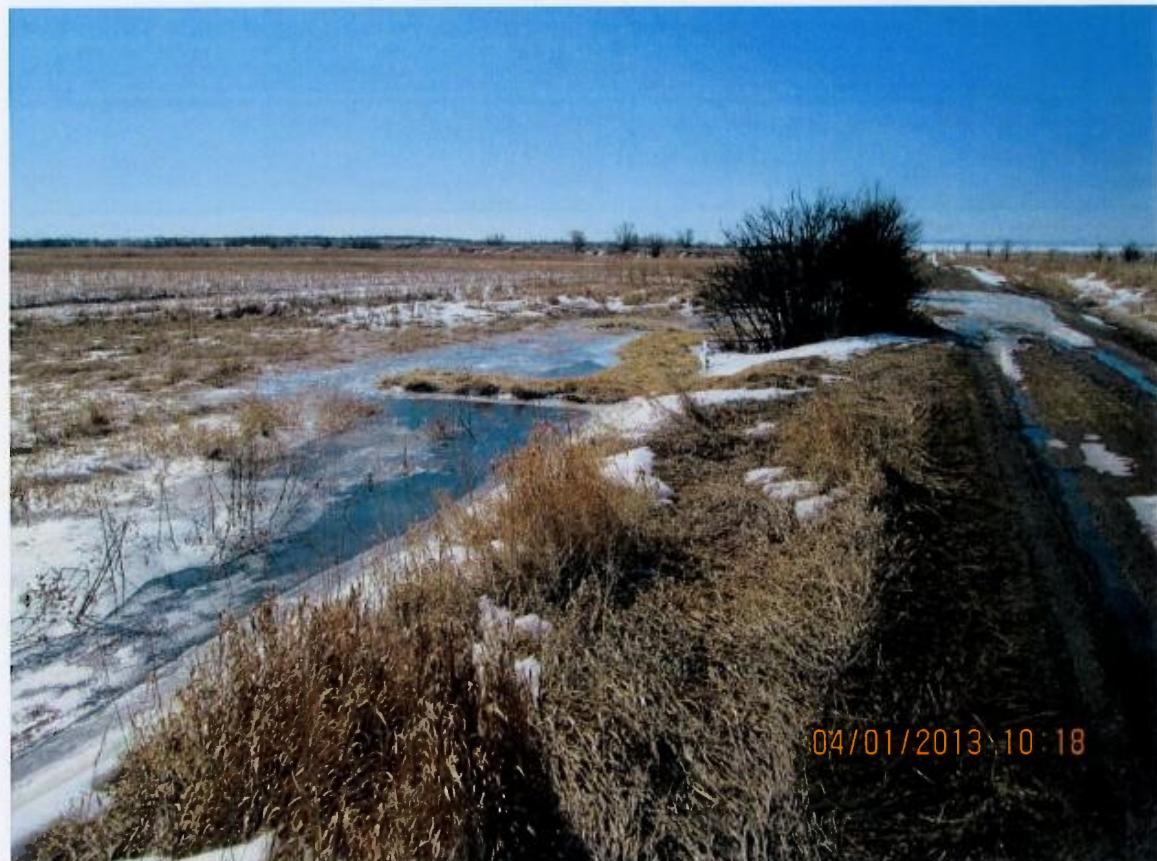
The area near the culvert connecting Sections 32 and 33 was observed. Both sides of the roadway were inspected. A photograph showing the area near the culvert is attached as Figure 1.

Figure 1. Area near culvert along roadway.

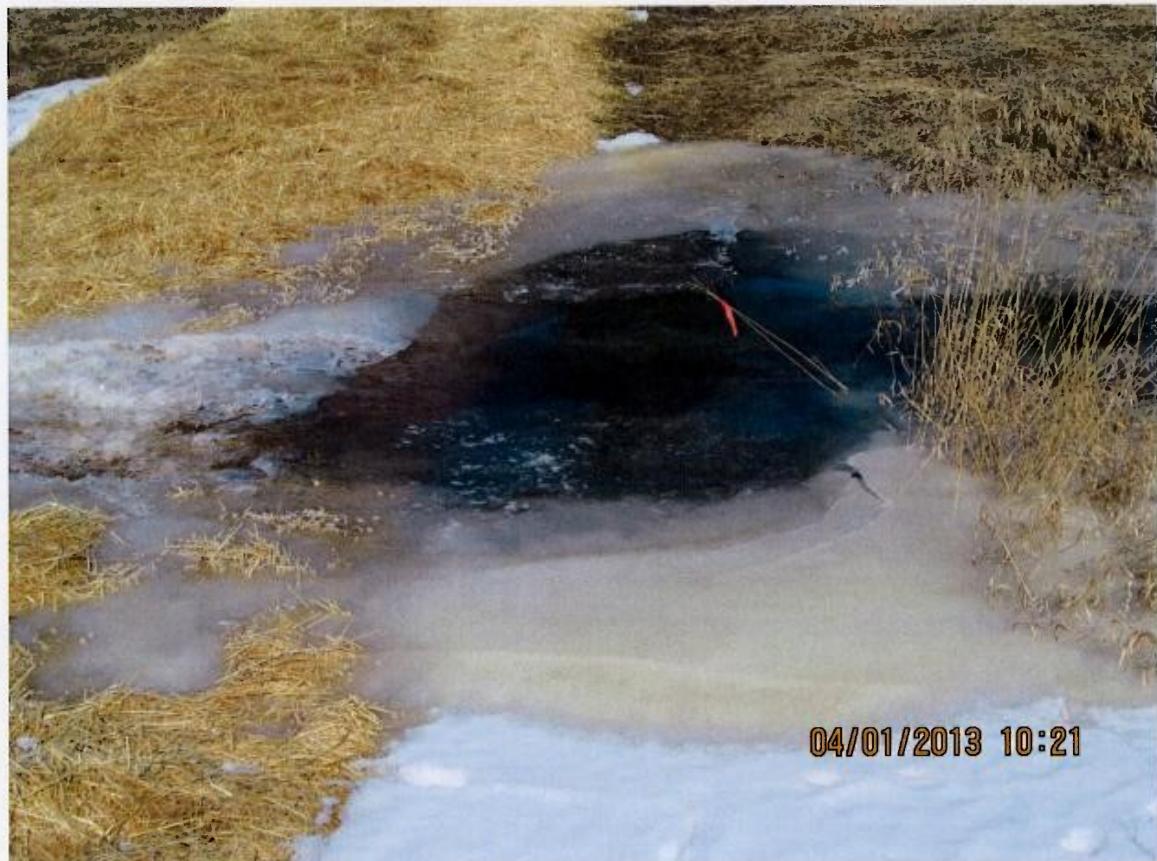
Figure 2. Water and ice near hay filter.

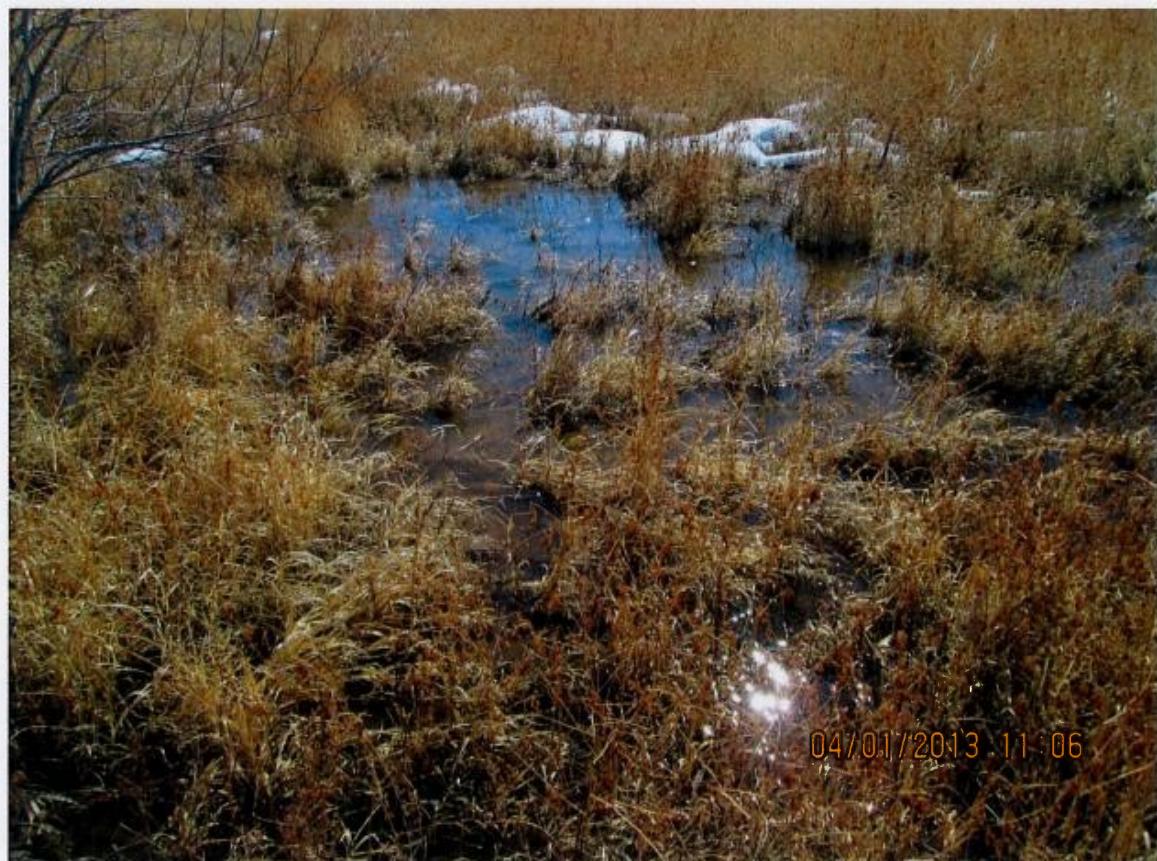
Figure 3. Standing water on Wildlife Management Area.

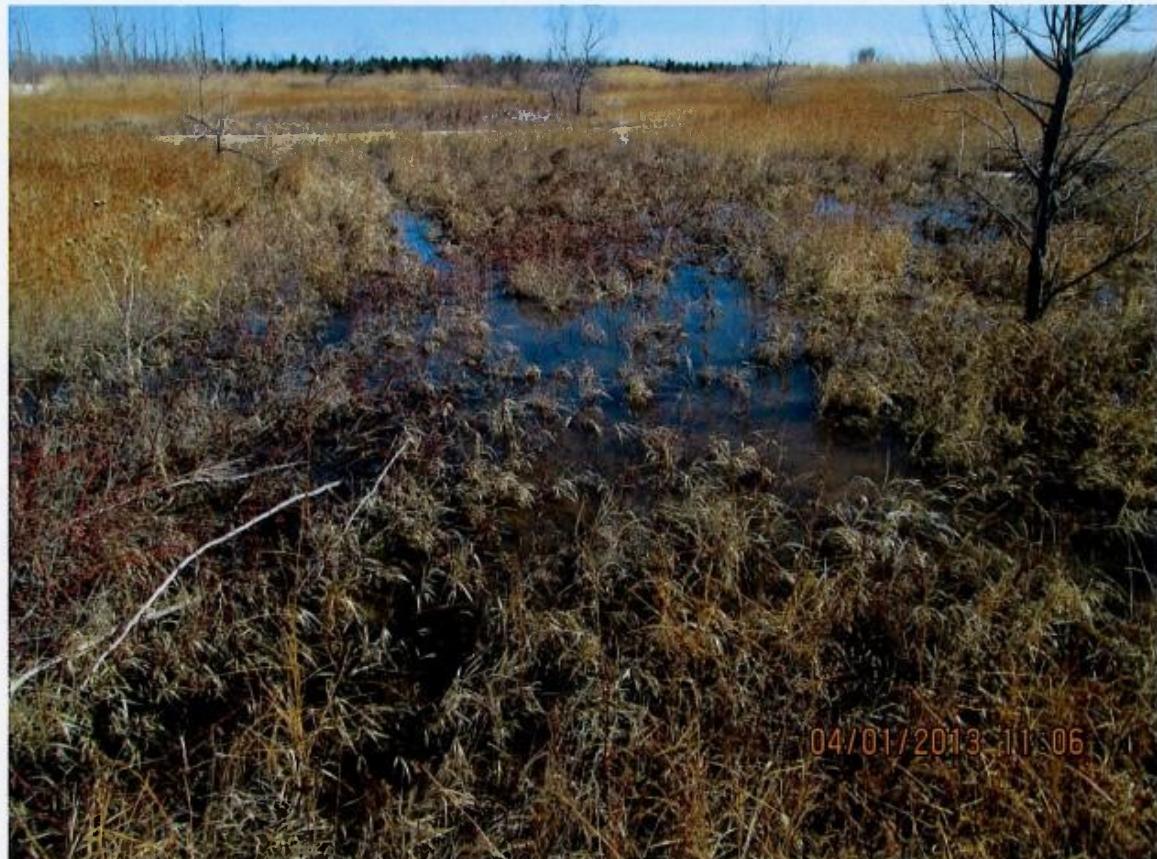
Figure 4. Standing water below west sorbent booms and hay filter strips on Wildlife Management Area.

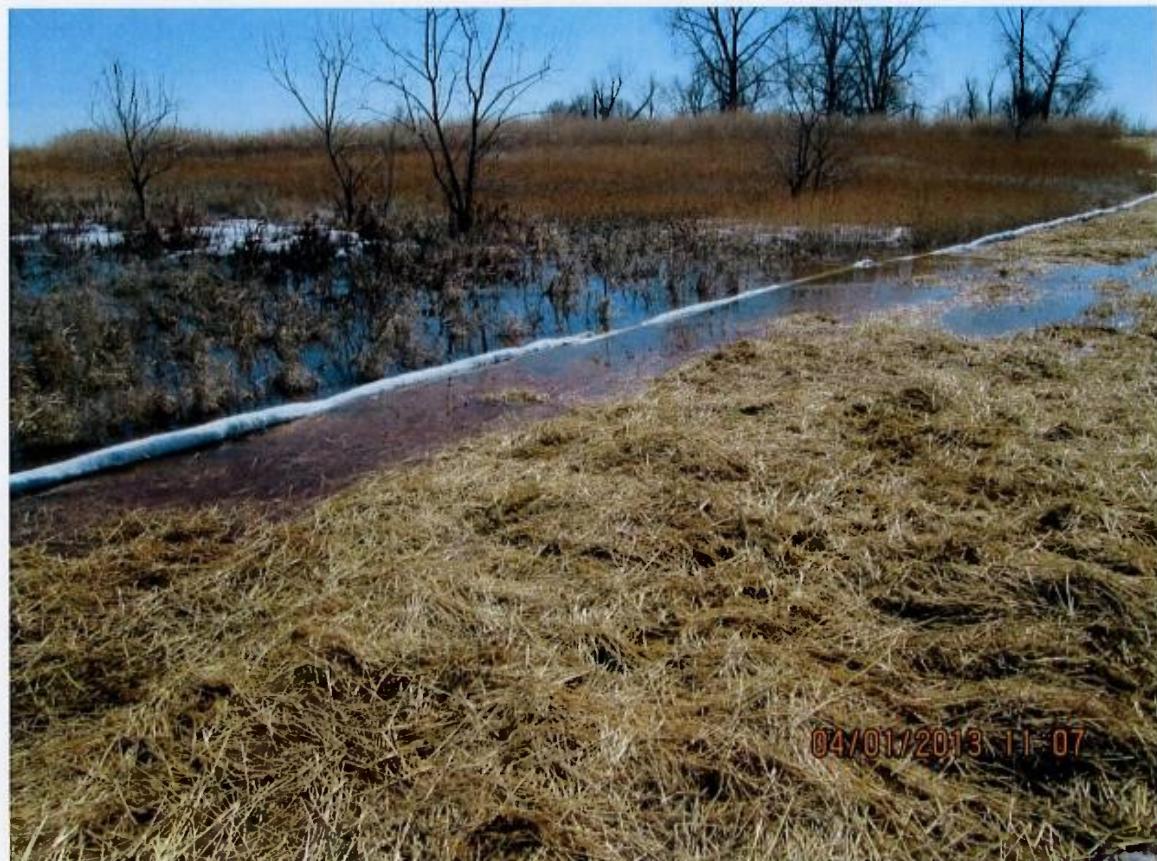
Due to prevailing weather conditions, Figure 5 shows sorbent booms which are submerged due to being frozen to the ground. During the time of the inspection, the ice holding the booms down melted, and the booms began to float on the surface of the water.

Figure 5. West drainage on Wildlife Management Area showing sorbent booms and hay filter strips.

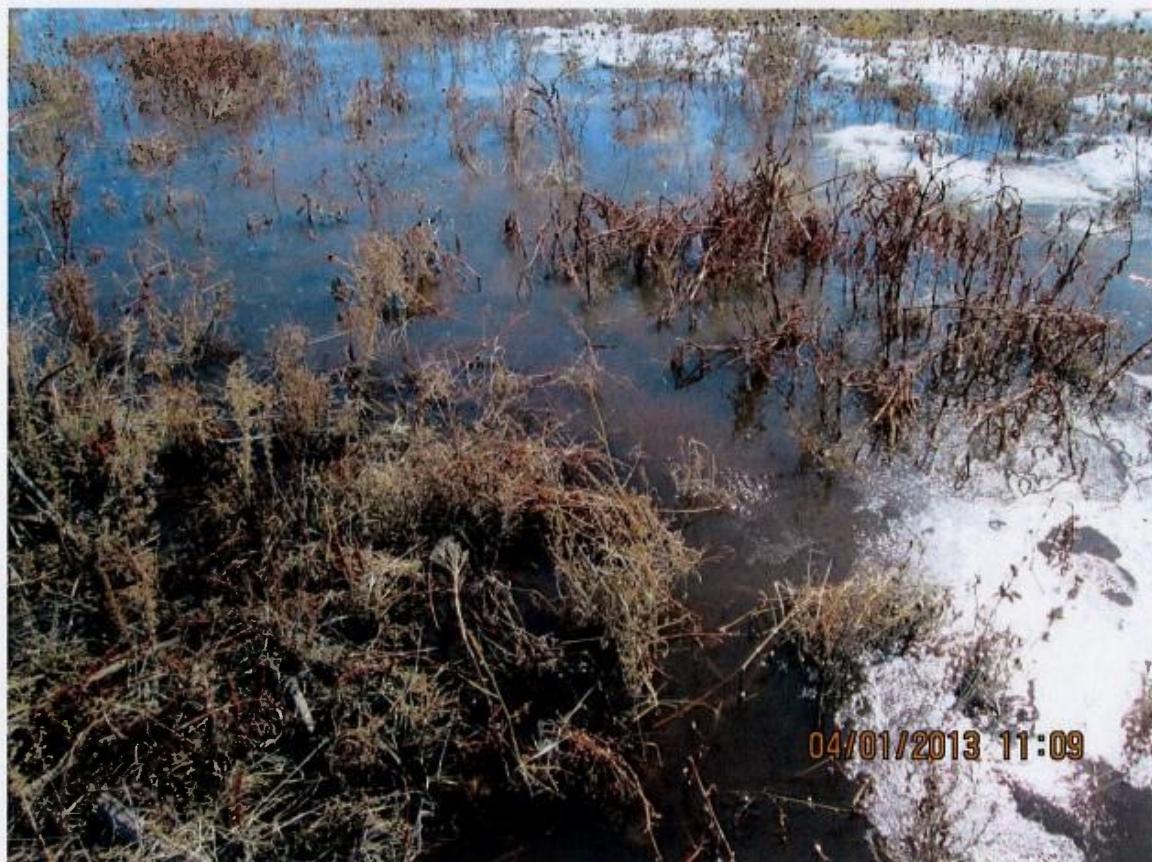
Figure 6. Standing water and ice above west sorbent booms and hay filter.

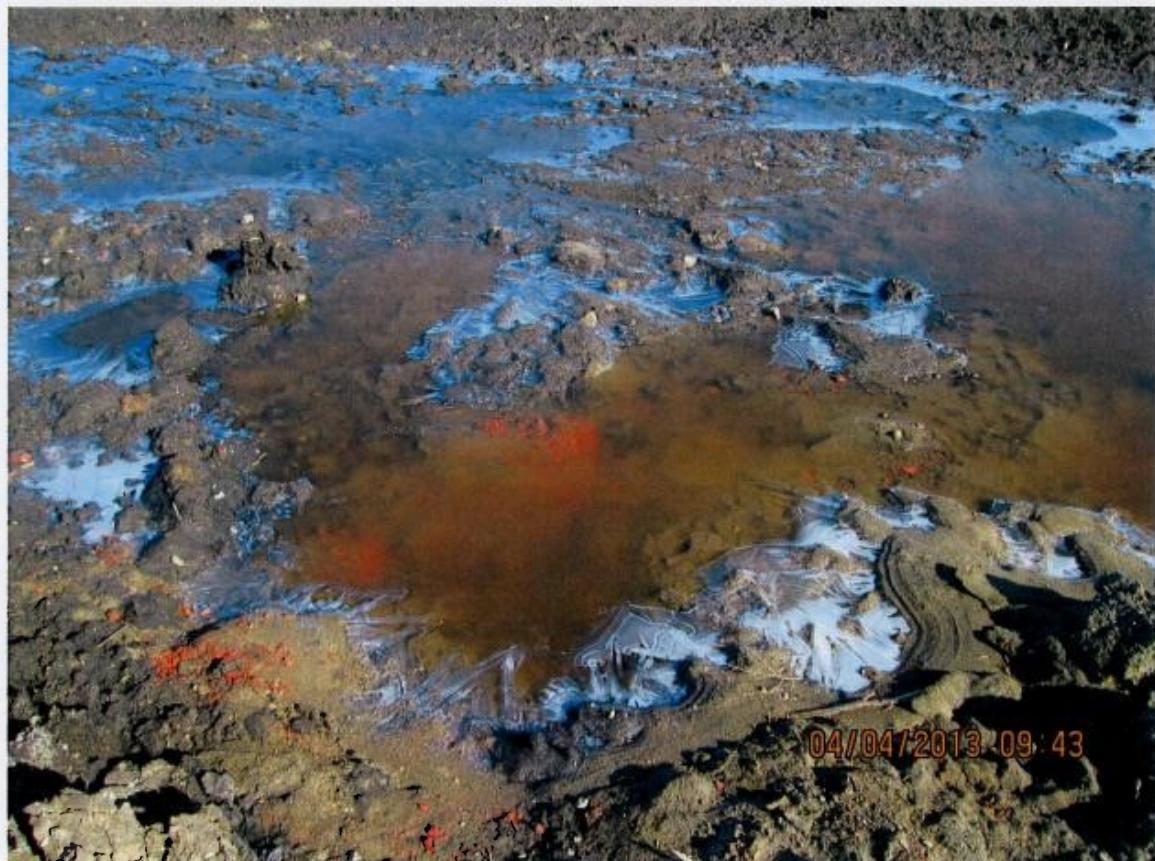
Arrived at Lunker at 1035 hours. The inspection began near at the northeast corner of the pad, and continued toward the lake. The area near the pad culvert was inspected. No signs of a sheen or floating oil and grease were observed.

Figure 7. Pad culvert.

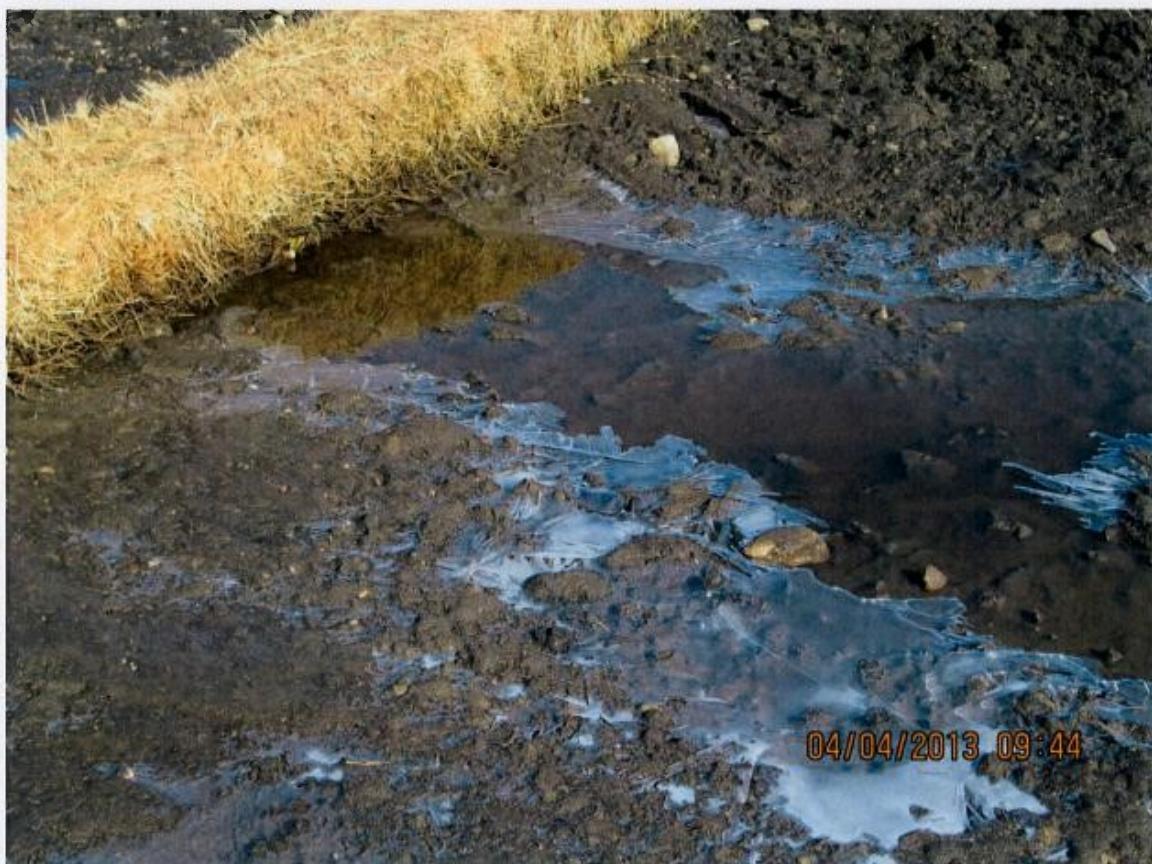
Figure 8. Drainage ditch north of pad.

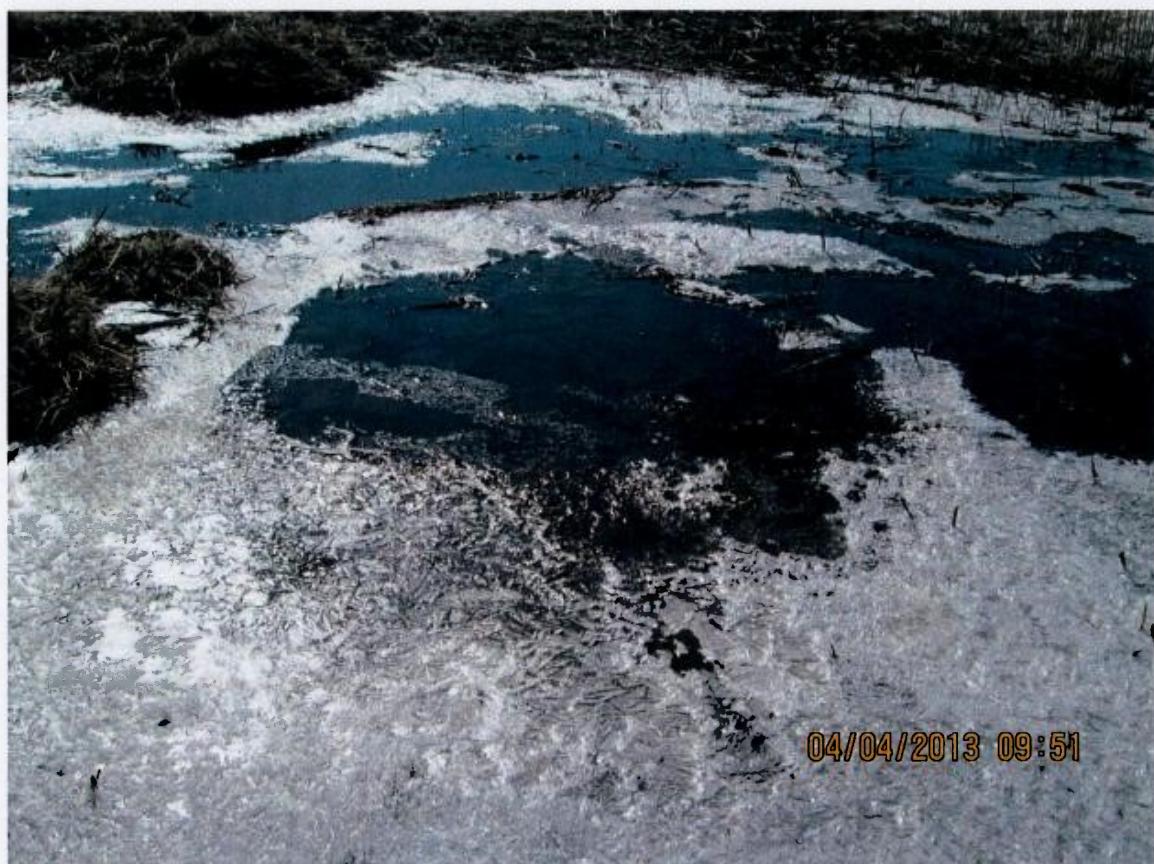
Figure 9. Area where temporary berm was located.

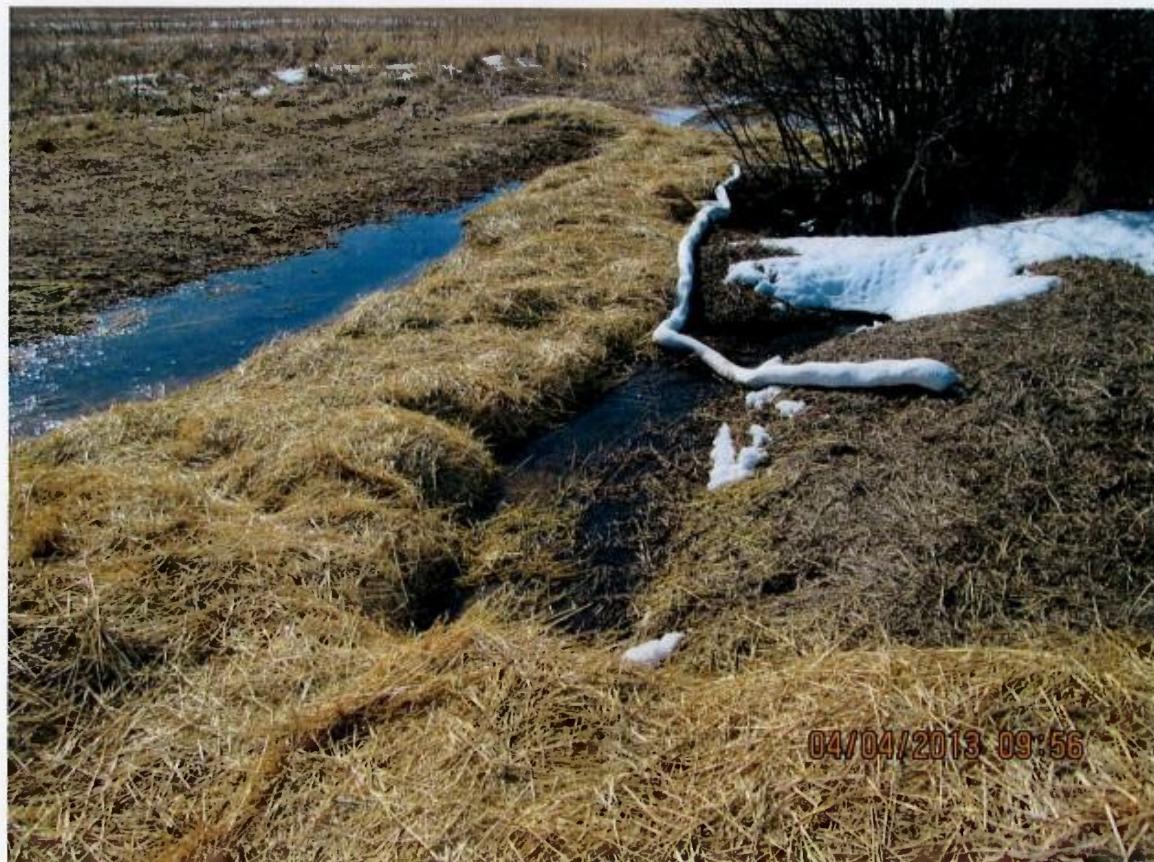
Figure 10. Hay filters and sorbent boom near culvert.

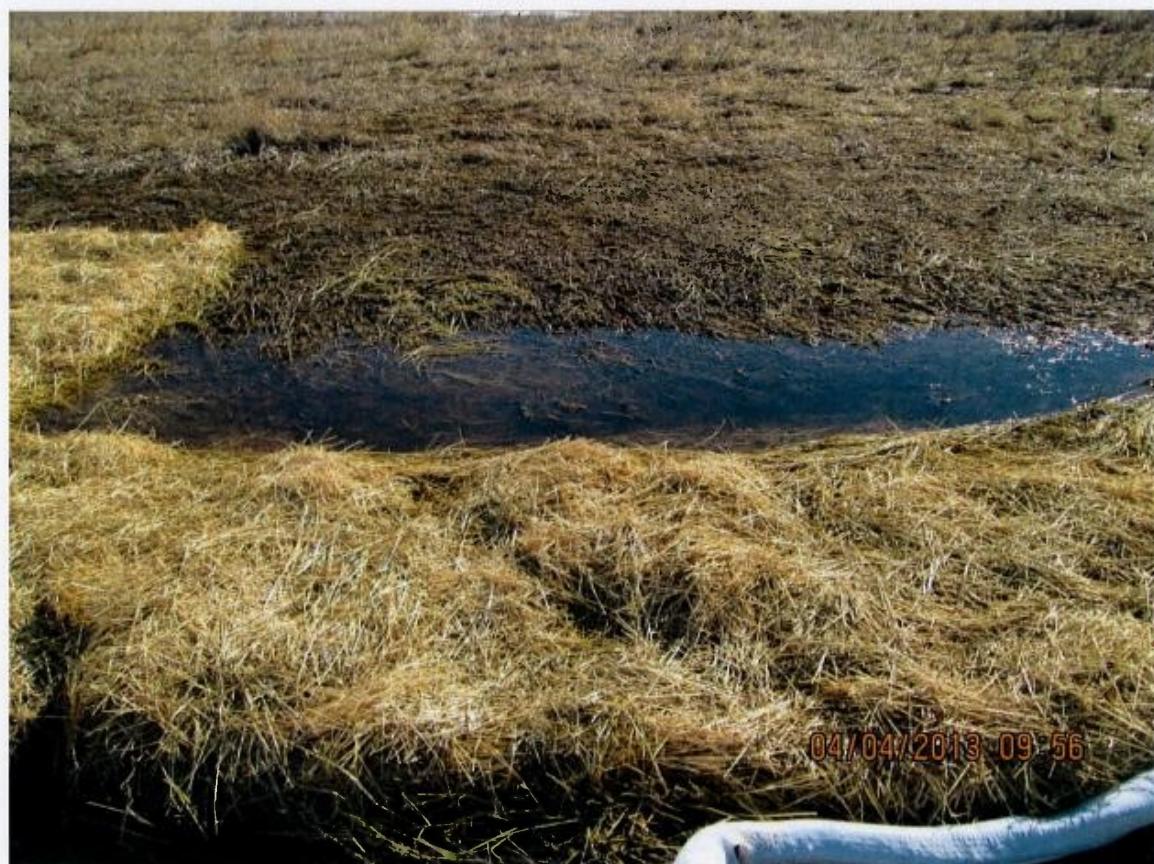
Figure 11. Standing water alongside hay filter.

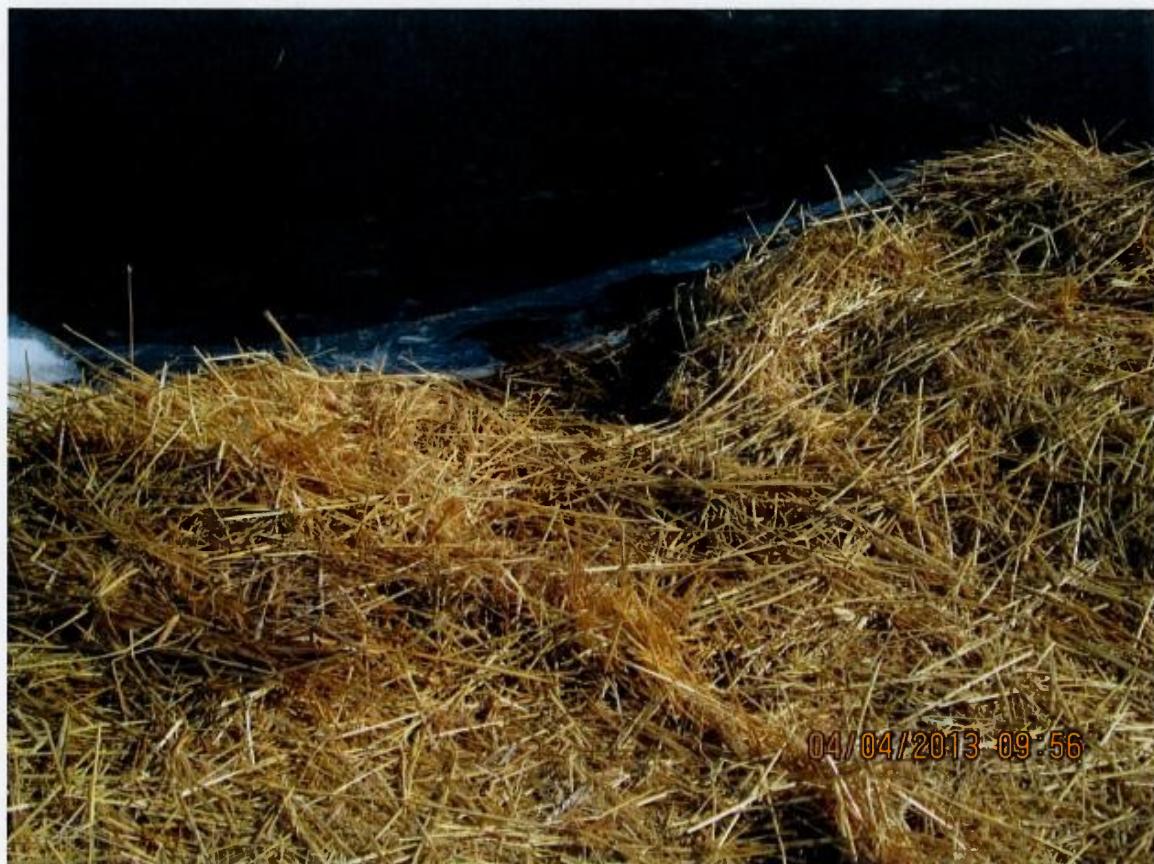
Figure 12. Close-up photo of standing water featured in Figure 11.

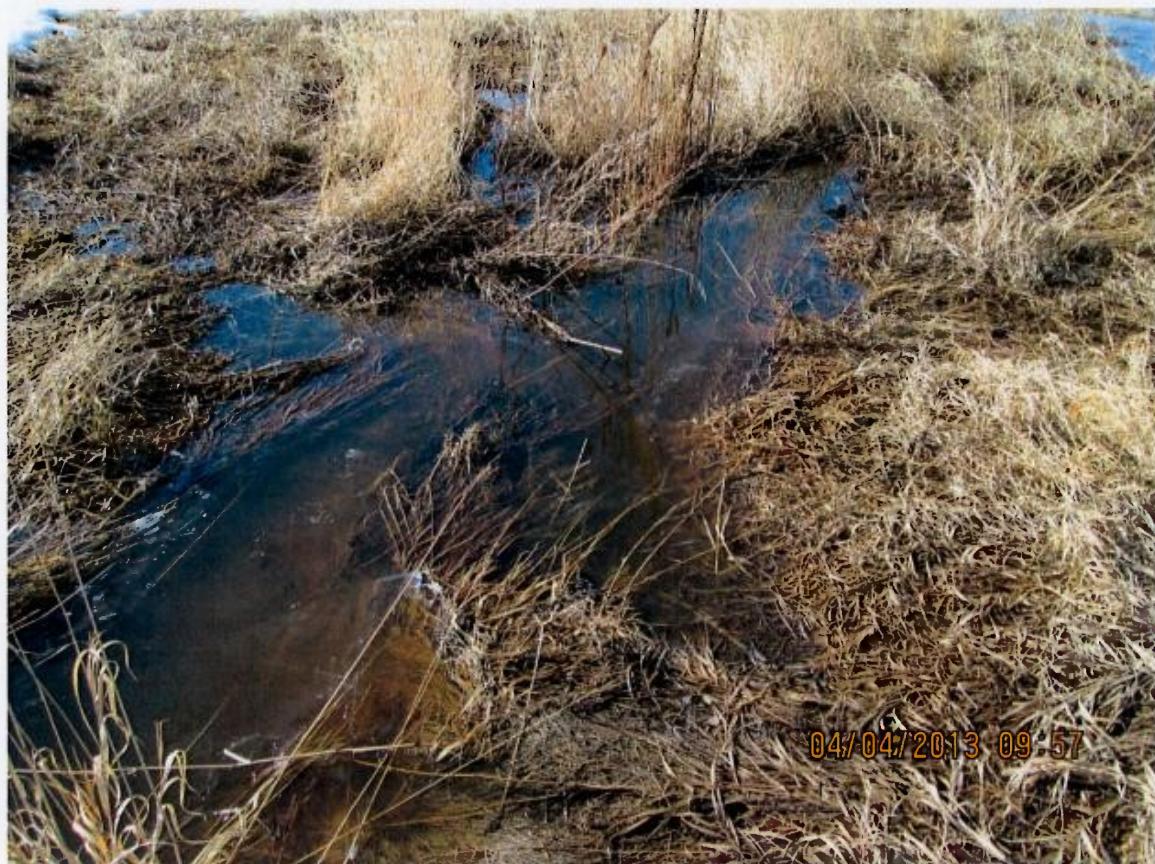
Figure 13. Culver out flow between Sections 32 and 33.

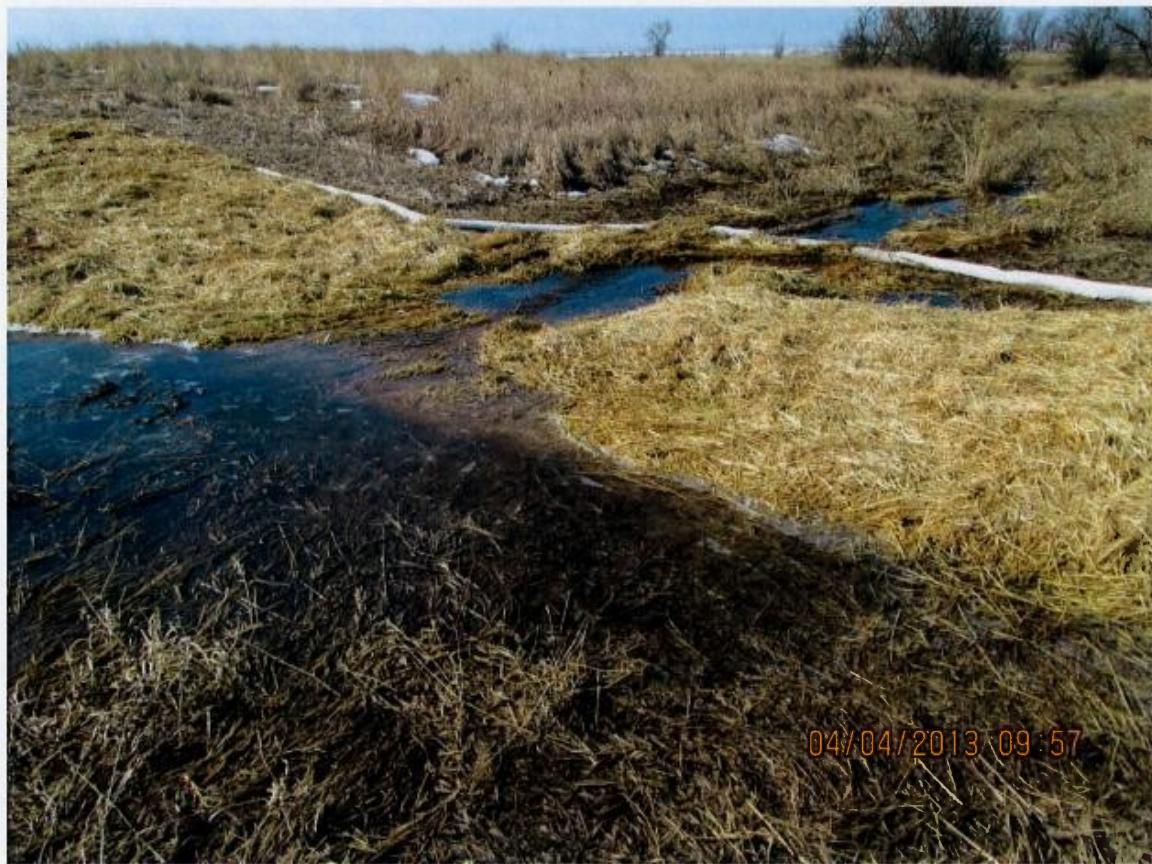
Figure 14. Picture of sorbent booms and hay filters in east drainage.

Figure 14 shows that some of the hay filter has been breached by flowing water. It is recommended that this hay be replaced. It is important to note the sorbent boom is still in place.

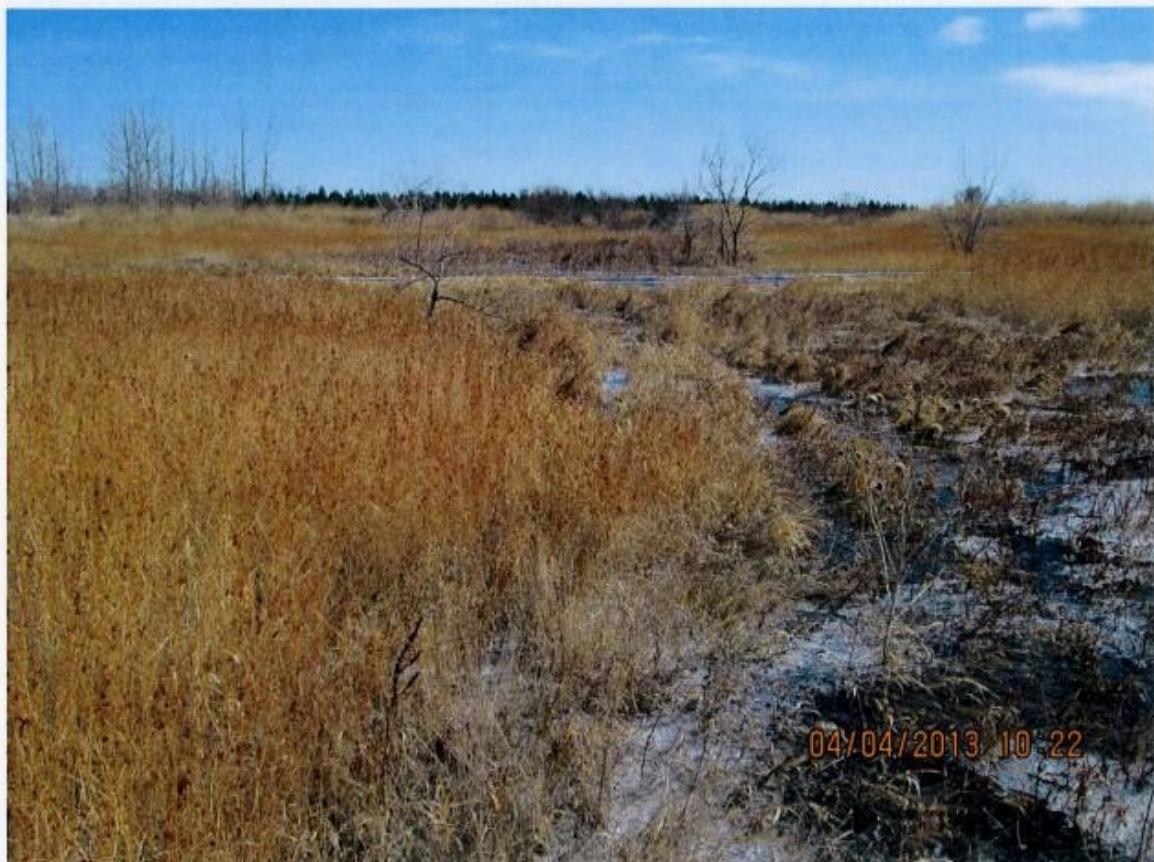
Figure 15. West drainage downstream of sorbent booms and hay filters.

No visible sheen or floating petroleum.

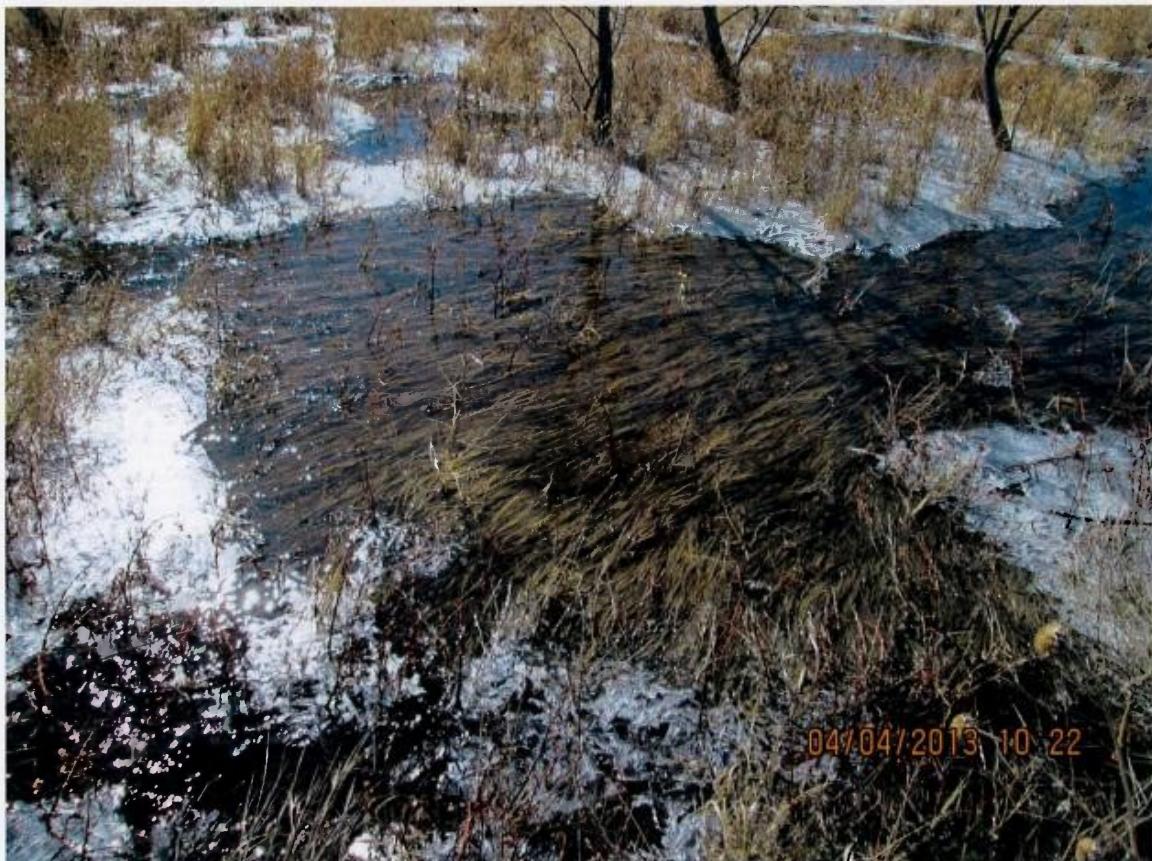
Figure 16. Drainage area above west drainage booms and hay filters.

No visible sheen or floating petroleum.

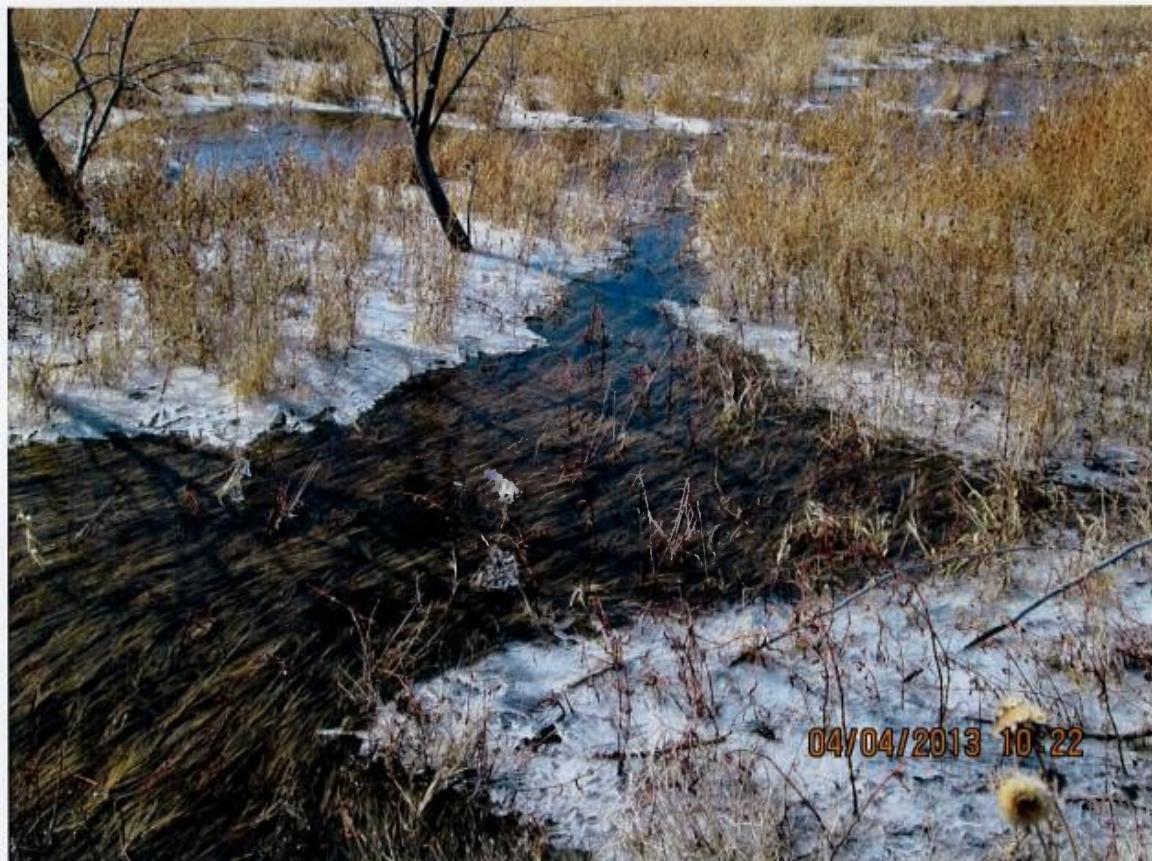
Figure 17. Additional drainage above west booms and hay filters.

No visible sheen or floating petroleum.

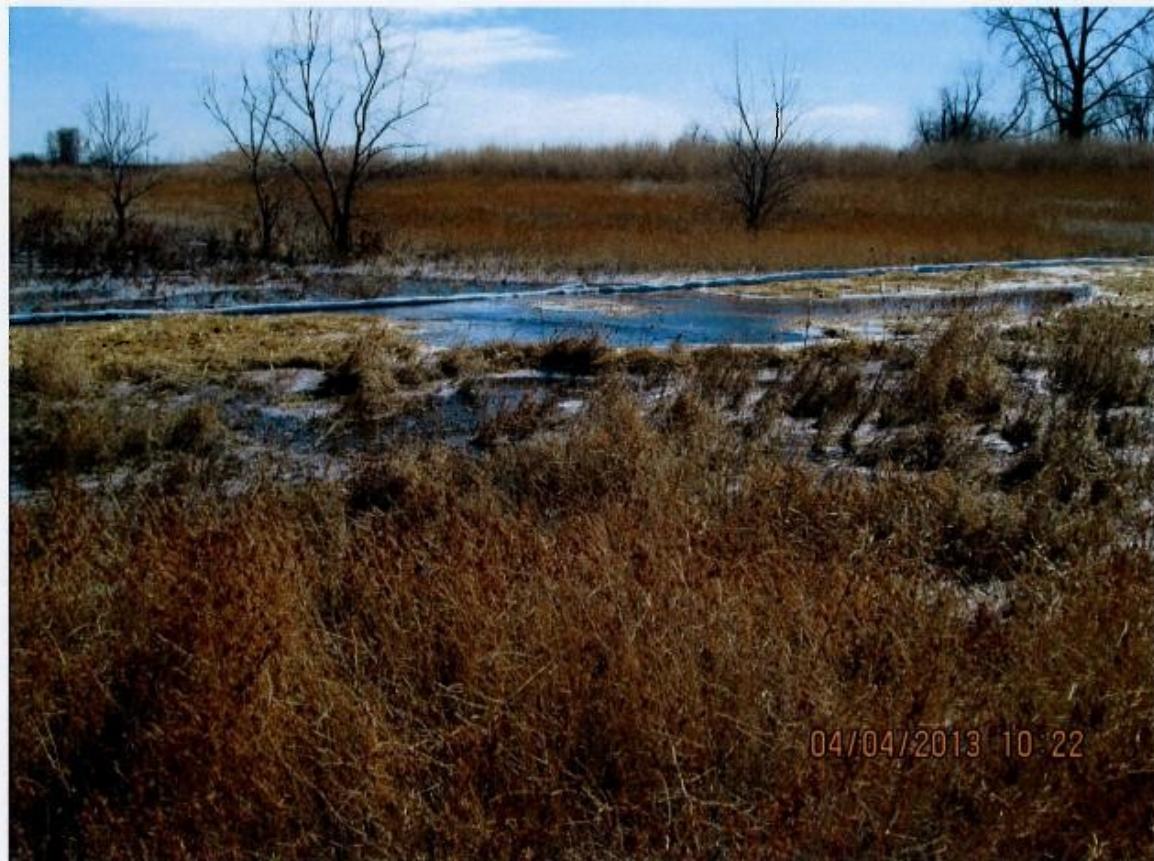
Figure 18. View of west booms and hay filter from a second perspective.

No visible sheen or floating petroleum.

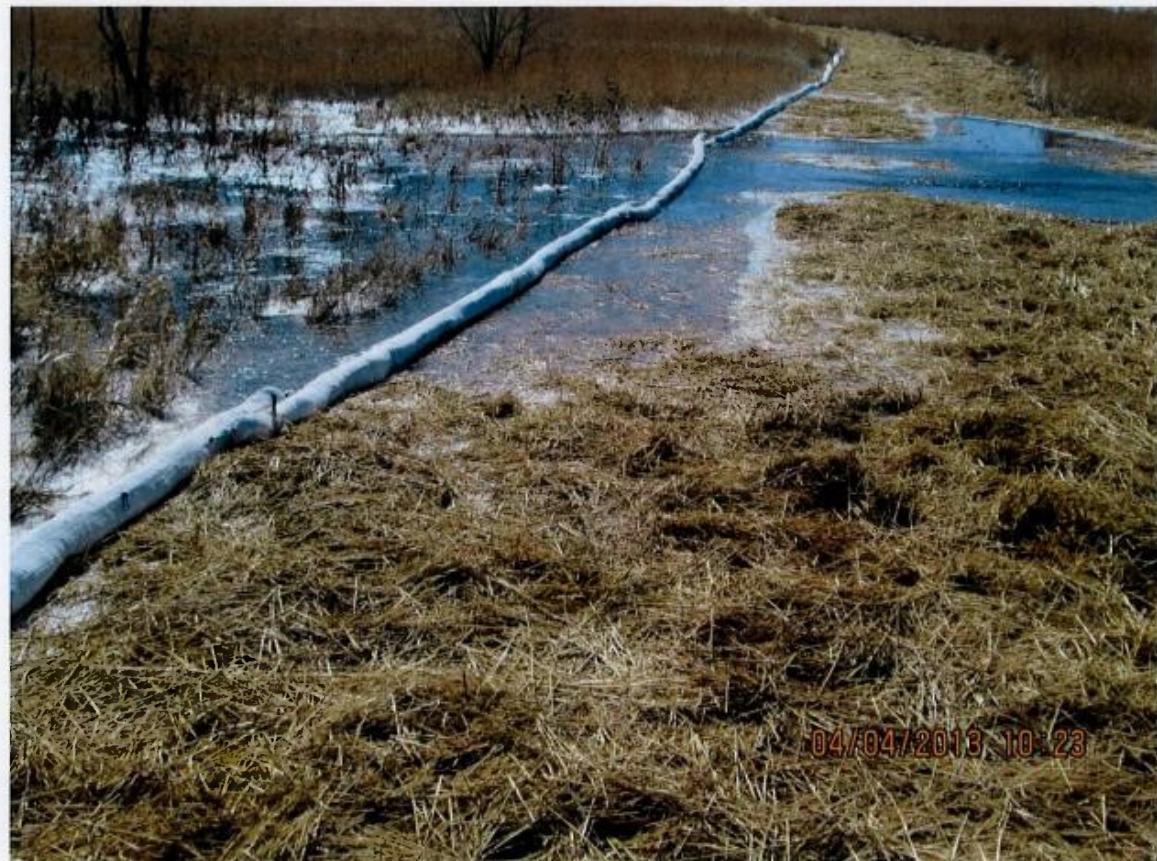
Figure 19. Flow of water through west hay filter strip.

No visible sheen or floating petroleum.

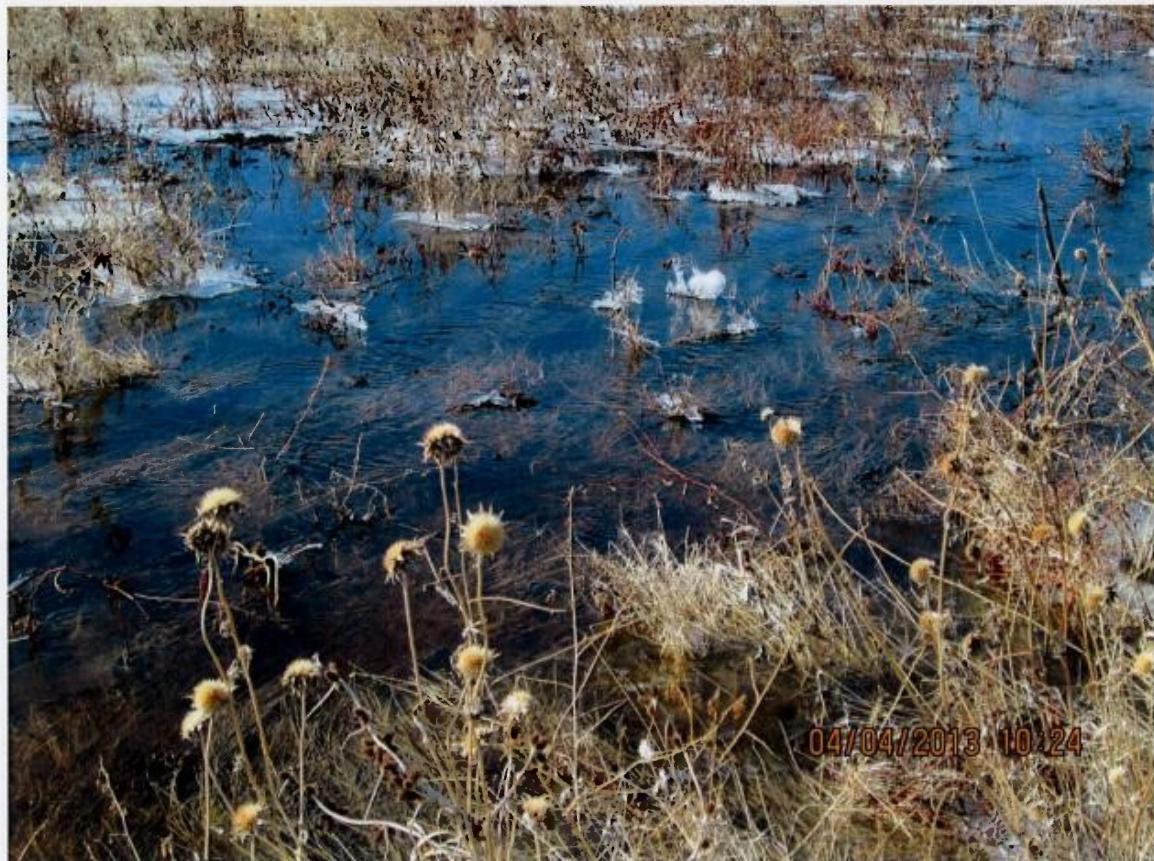
Figure 20. Water flow below the booms and hay filter strips.

No visible sheen or floating petroleum.

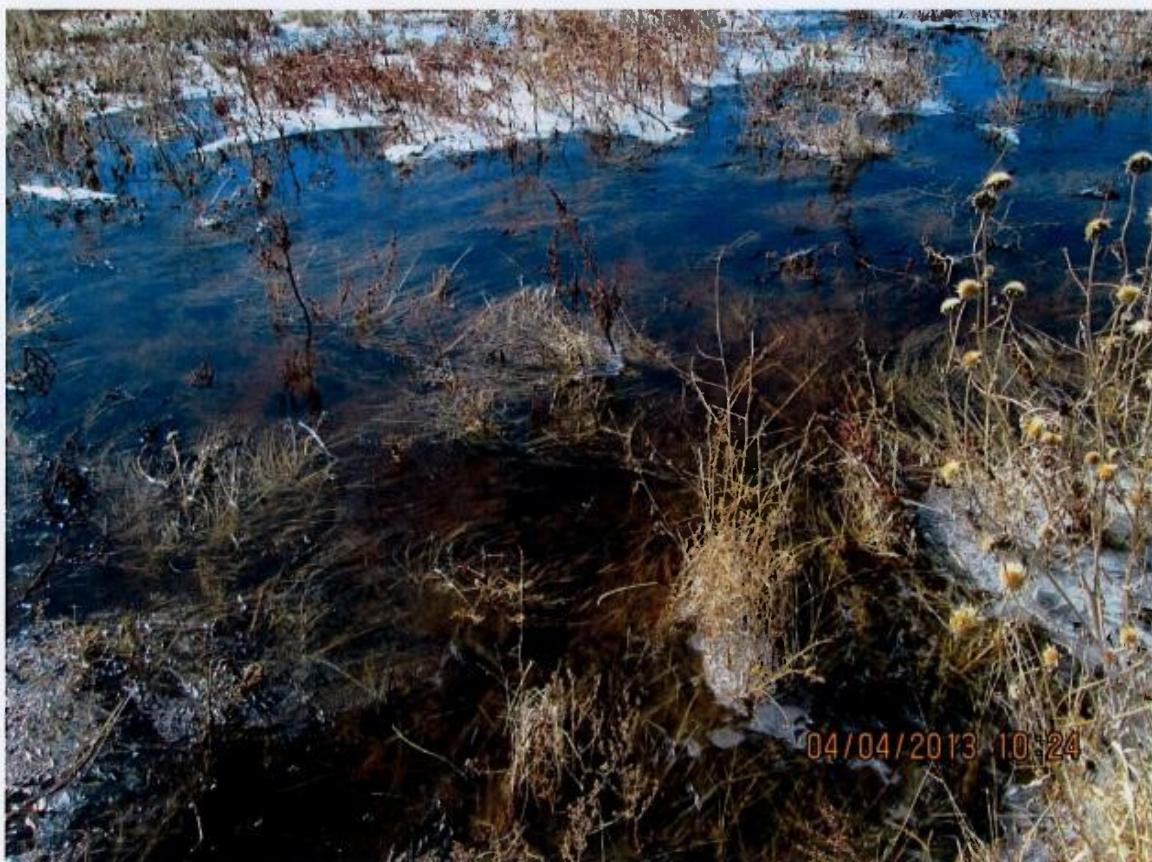
Figure 21. Water flow above the west booms and hay filter strips.

No visible sheen or floating petroleum.

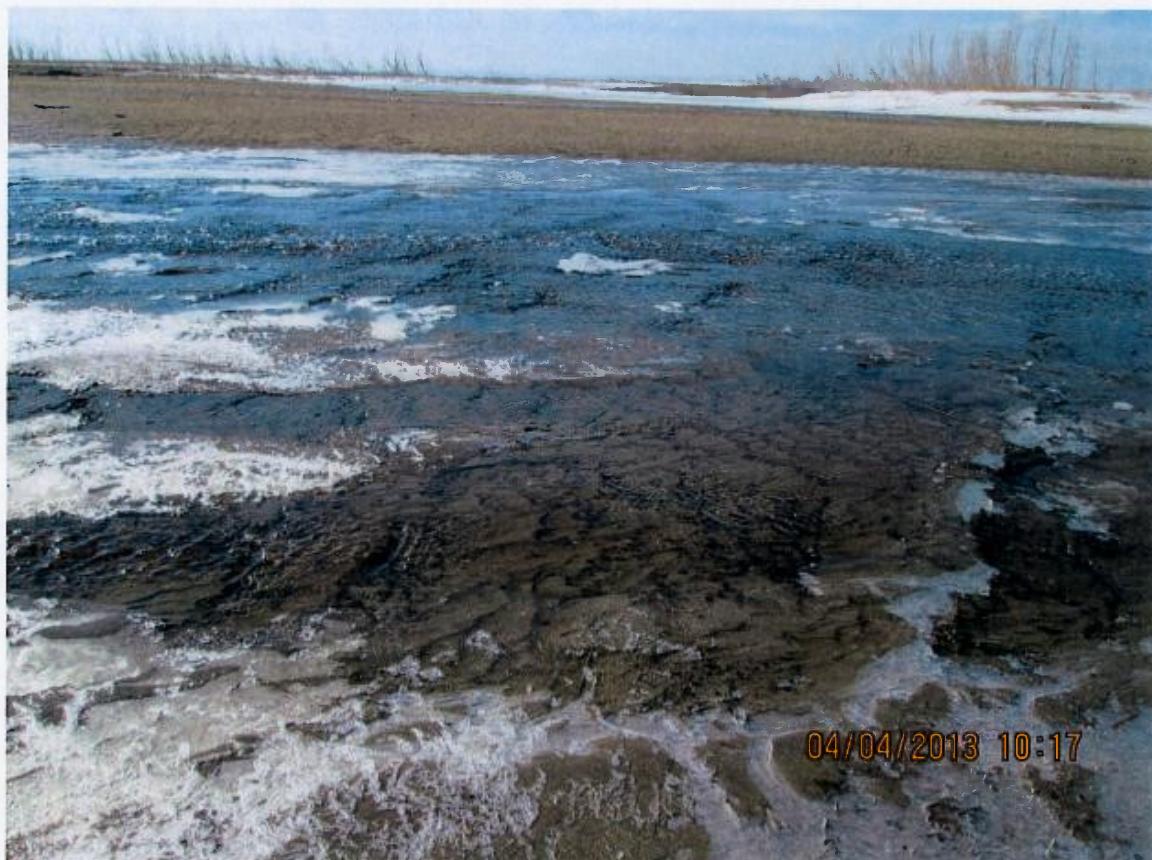
Figure 22. Drainage area along shoreline.

No signs of sheen, or floating petroleum were visible at the point where the water enters the lake.

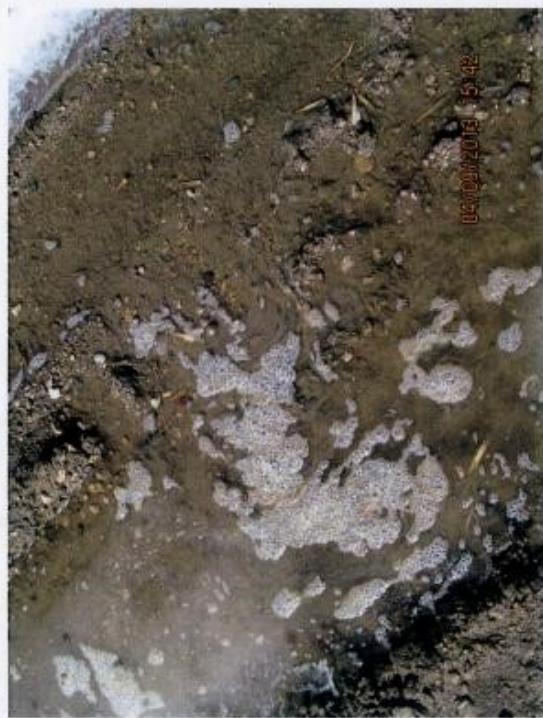
Figure 42.

General conditions of the Wildlife Management Area (WMA) during this survey included no movement of water due to ambient temperature and the fact that very little snow remained in the area. Pools of iced over water could be found. No visible petroleum sheen was observed at any location. Some biological mass was observed within the RV park. Figures 42 and 43 record the observed biological mass observed within the RV park.
